INDOOR AIR QUALITY ASSESSMENT

**Danforth Building
123 Union Avenue
Framingham, MA**

Prepared by:
Massachusetts Department of Public Health
Bureau of Environmental Health
Indoor Air Quality Program
June 2016

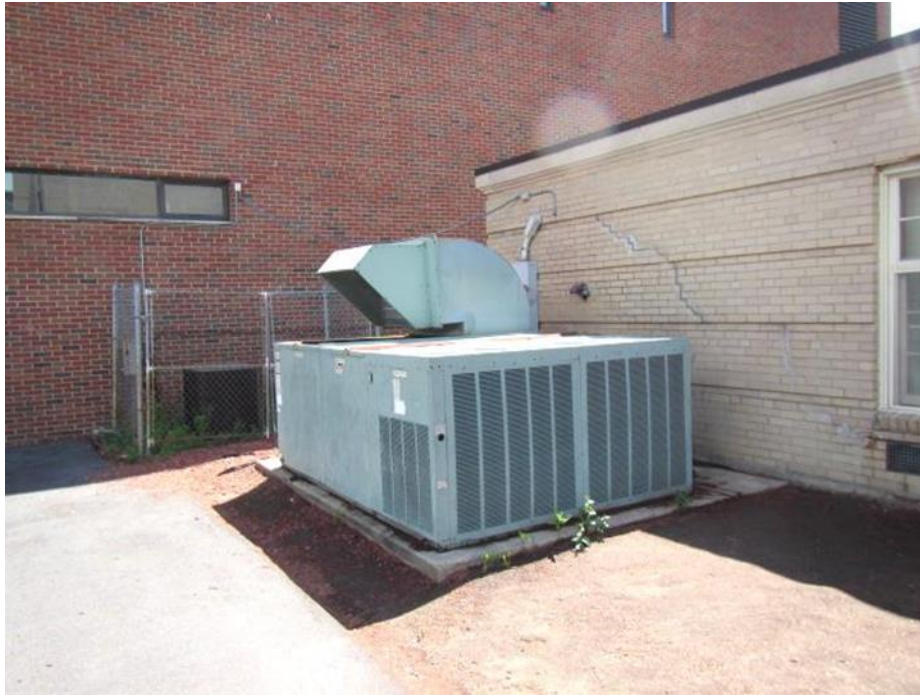
Picture 1

The Danforth Building has no functioning mechanical ventilation in most areas. The Gym area on the second floor of the annex has an exhaust system. The Boys and Girls Club area is connected to an HVAC system which provides heat and cooling but reportedly does not introduce fresh air (Picture 1). There is an abandoned ventilation system for the original part of the building that has reportedly not been functional in 20 years. Without fresh air supply and exhaust ventilation, commonly found indoor air pollutants may be allowed to concentrate in occupied space. It was also reported that individual tenants are responsible for preventative maintenance of their HVAC units; it was not clear if any cleaning or filter changes were being performed in the existing units.

Air handling unit for the Boys and Girls Club

8. Change HVAC filters a minimum of 2 times a year, with units vacuumed thoroughly inside and drip pans cleaned. Consider using filters of a minimum efficiency reporting value (MERV) of 8 or better filters.

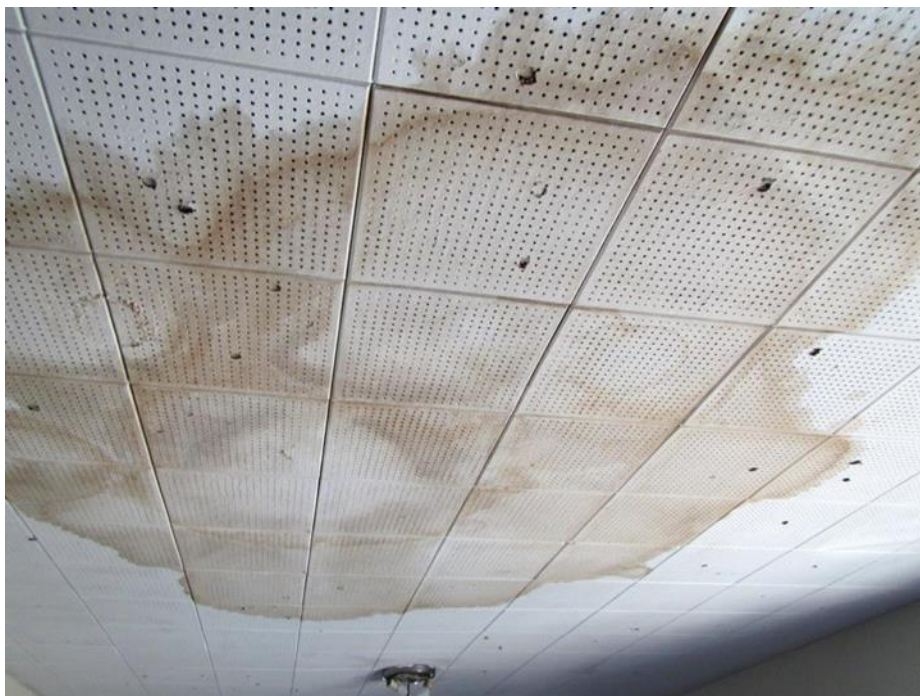
Picture 2

There are several sources of moisture and water damage in the building. Water-damaged walls and ceilings were observed in many areas (Pictures 2 through 7), indicating leaks from the building envelope (roof and walls). Some of the water-damaged materials appeared to be mold-colonized (Pictures 5 through 7). Efflorescence was also observed in brickwork and plaster in some areas (Pictures 8 and 9). Efflorescence is a characteristic sign of water damage to building materials such as brick or plaster, but it is not mold growth. As moisture penetrates and works its way through mortar around brick, water-soluble compounds dissolve, creating a solution. As the solution moves to the surface of the brick or mortar, water evaporates, leaving behind white, powdery mineral deposits. This condition indicates that chronic moisture has penetrated into the building. Plaster and brick do not generally grow mold because they do not contain a source of carbon, however paint, dust/debris or items near the walls that are also moistened may become mold-colonized.

Water-damaged ceiling tiles

Water-damaged porous building materials such as gypsum wallboard (GW) and ceiling tiles can become mold-colonized and should be removed after water leaks are repaired. The roof membranes, brick siding, flashing and some windows all appear to be in need of inspection and repair/replacement if the building is to continue to be occupied. Without stopping the source of moisture infiltration, chronic water damage and microbial colonization will continue.

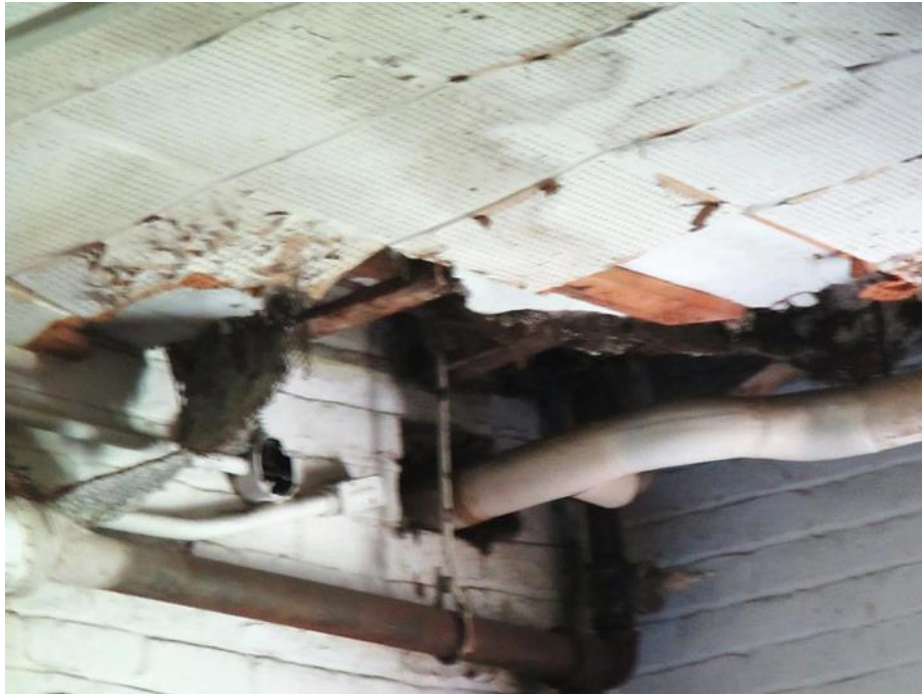
Picture 3

Severely water-damaged ceiling and ceiling tiles

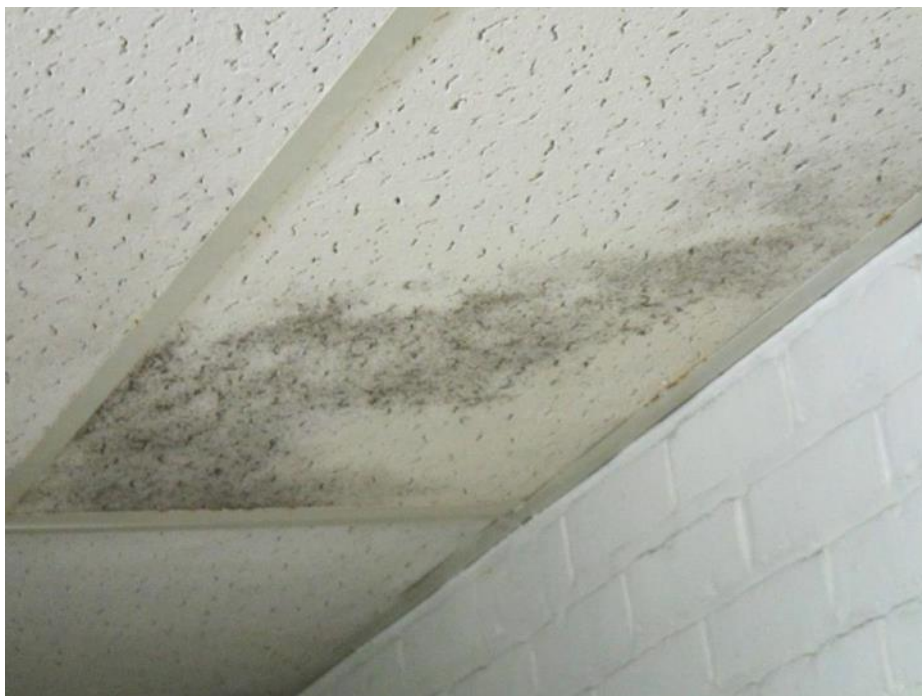
Picture 4

Water-damaged ceiling tiles, likely colonized by mold

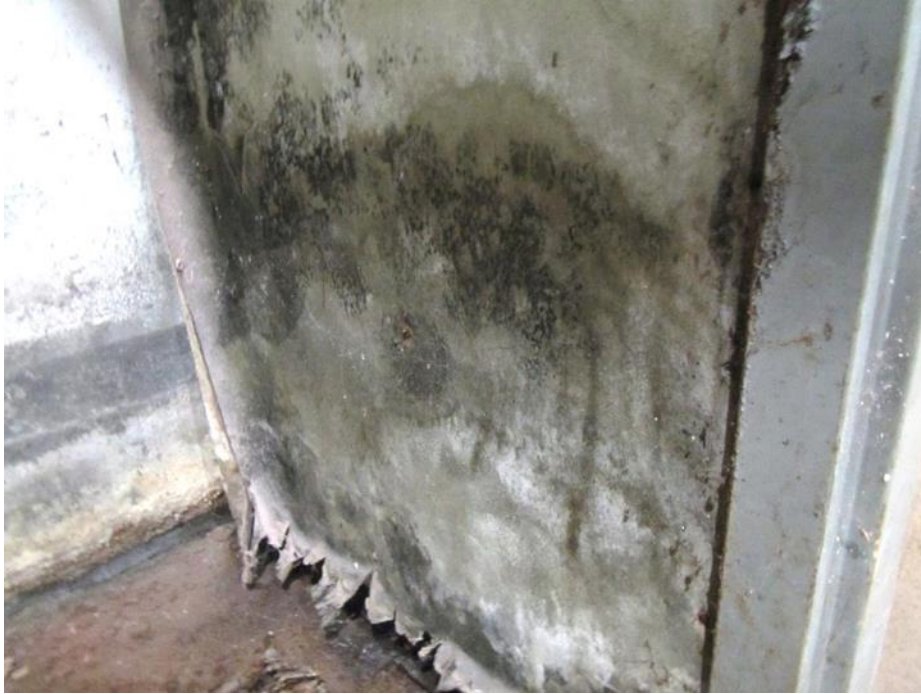
Picture 5

Mold-colonized wall

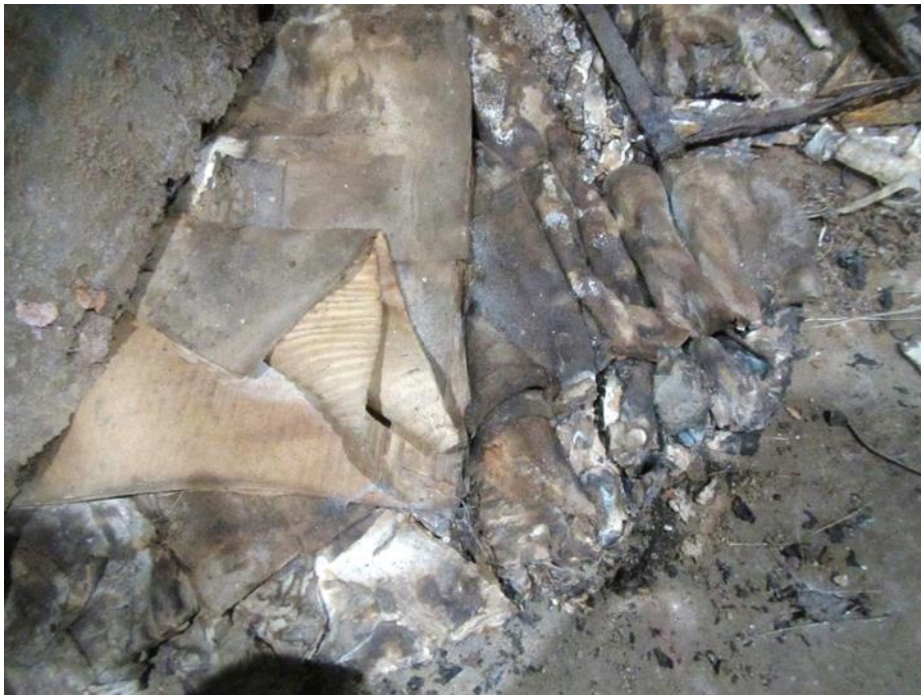
Picture 6

Water-damaged/mold-colonized cardboard

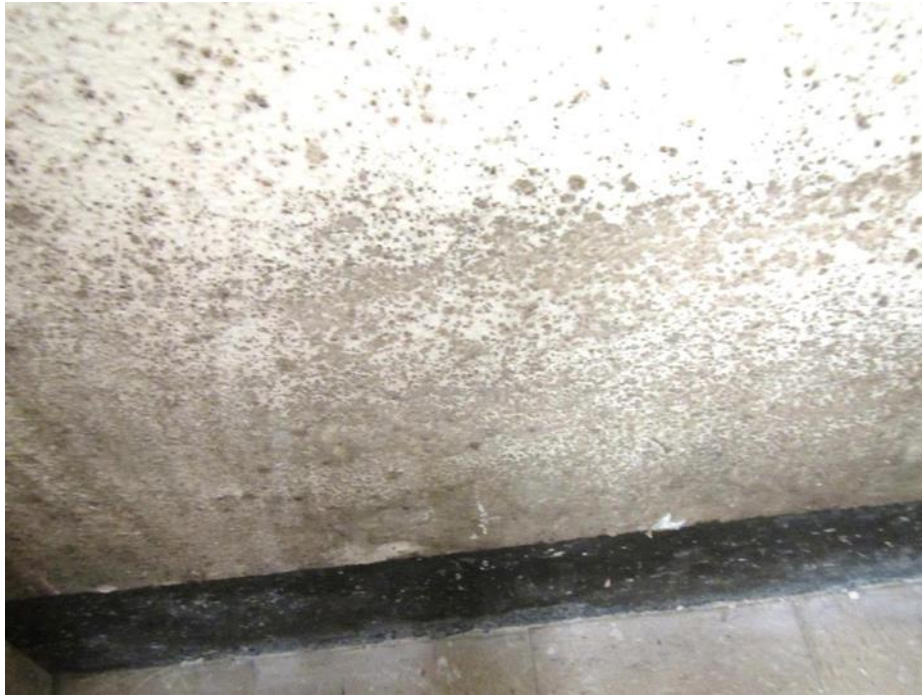
Picture 7

Mold-colonized wall

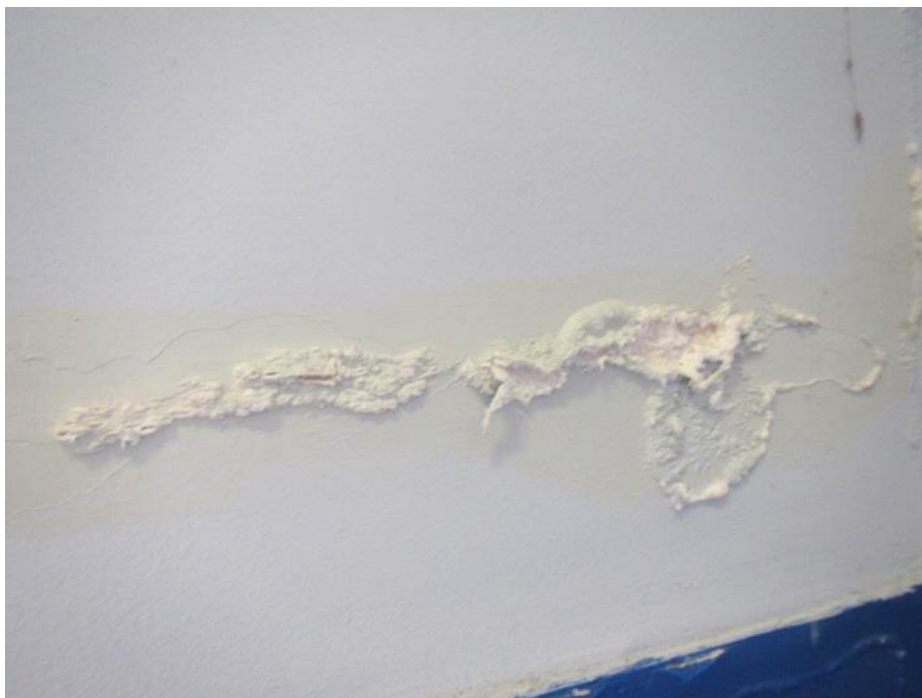
Picture 8

Efflorescence on interior wall

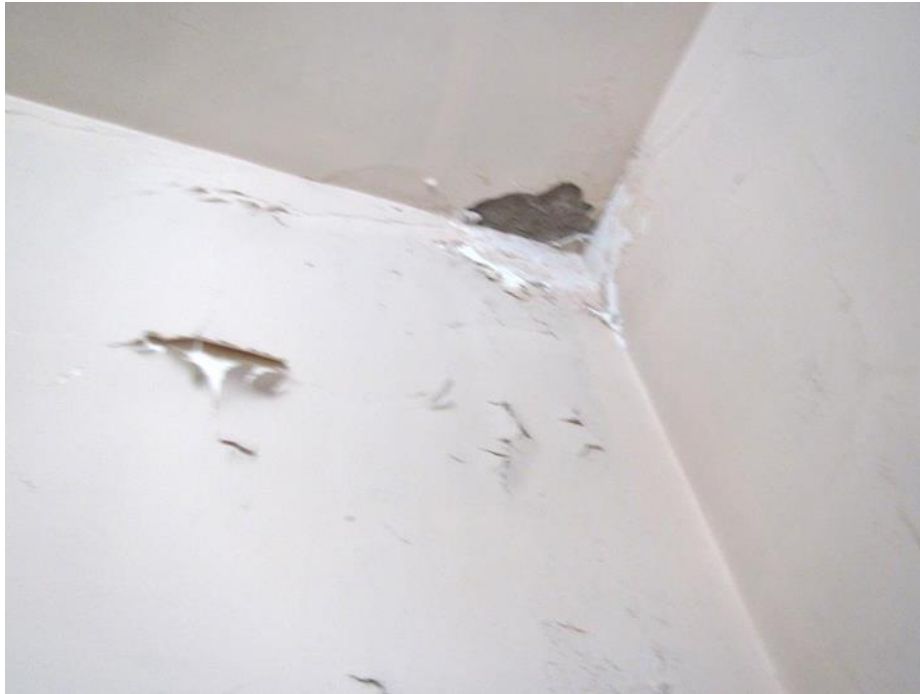
Picture 9

Peeling paint and efflorescence

10. Repair/repaint areas of peeling plaster on walls and the ceiling. If lead paint may be an issue, ensure that lead-safe procedures are used in accordance with state and federal laws/regulations.

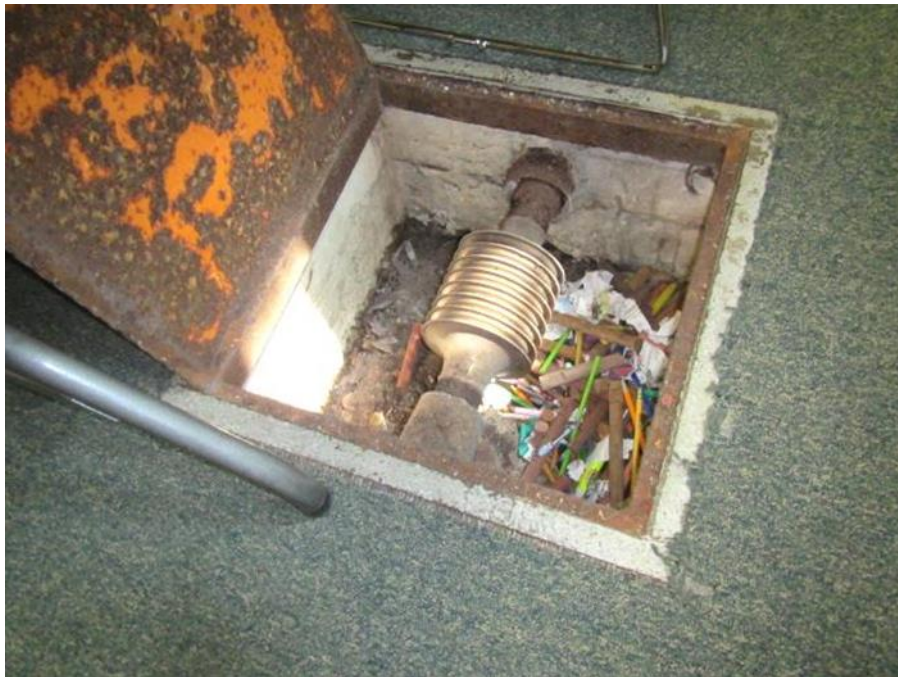
Picture 10

The steam condensation traps for the boilers (e.g., Picture 10) reportedly leak on a regular basis. Facilities staff reported that the pipes are disintegrating and are wrapped with a deteriorating asbestos insulation. These lines are below grade and have contact with soil, which

Steam trap for boilers

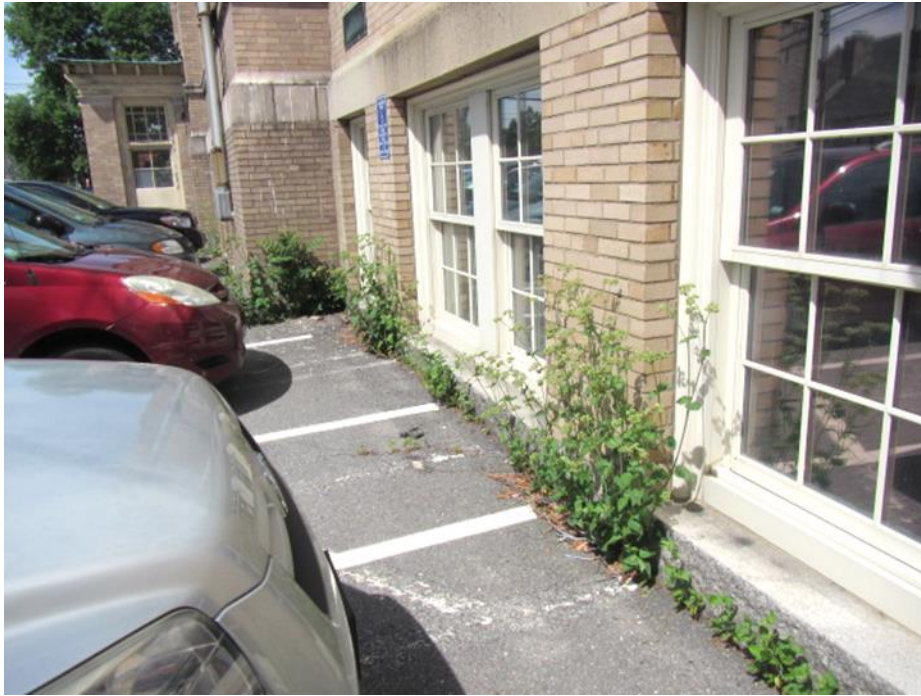
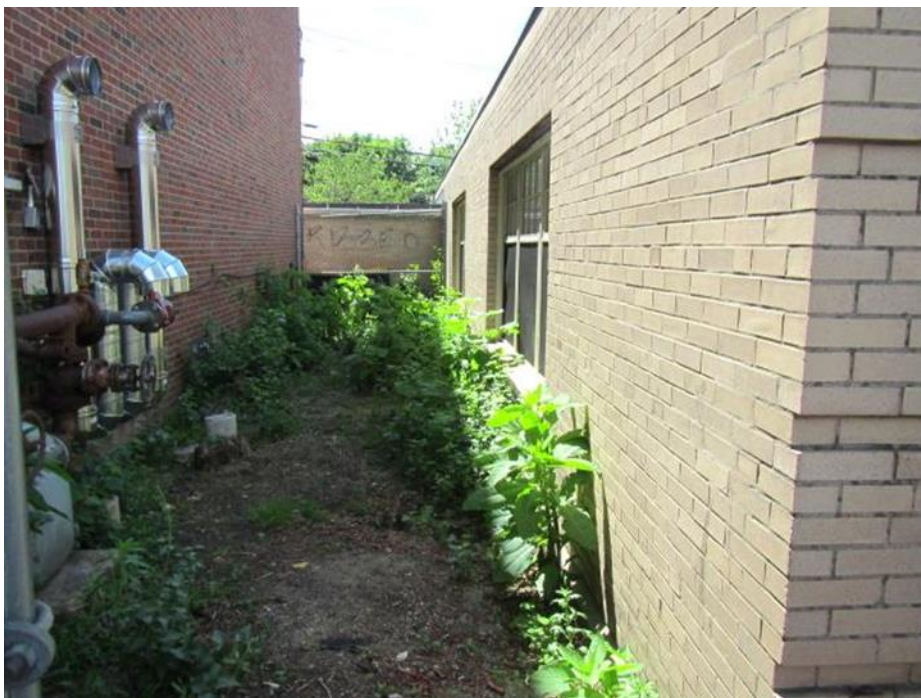
Plants were observed growing along exterior walls/against the building (Pictures 11 and 12). Plants/shrubbery can hold moisture against exterior masonry, causing damage to brick/mortar.

Plants growing against exterior masonry

14. Trim back plants/shrubbery to at least five feet from the building to avoid impingement of moisture on exterior walls/foundation.
15. Reduce the use of VOC-containing cleaners, sanitizers and scented products, especially given the lack of ventilation in this building. Consider using HEPA-equipped vacuuming, wet wiping, and soap and water for regular cleaning tasks to prevent the introduction of VOCs and other potentially irritating chemicals into the indoor air.

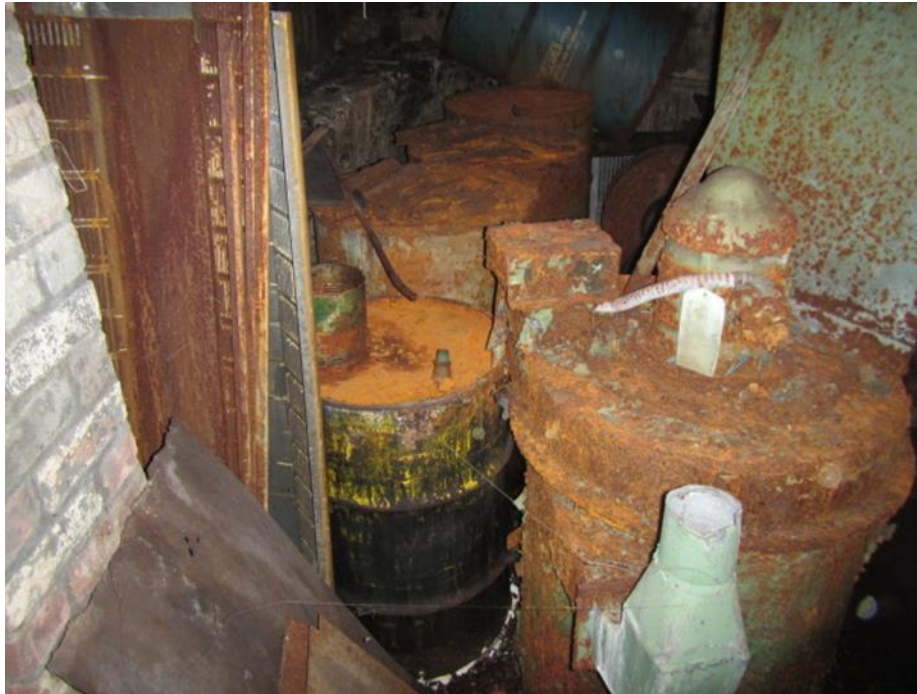
Picture 13

Several 50-gallon metal drums containing an unknown material were observed in the basement (Picture 13). The bottoms of these containers were corroding, which could result in a release of material. At the time of the assessment MDPH staff recommended that the material be

Severely corroded drums of unknown material in the basement

removed from the building as soon as possible. Mr. Jim Paolini, Director of Capital Projects and Facilities Management, reported that the material had been tested and removal will commence upon receiving the testing results.

2. Continue with plans to identify and remove 50-gallon drum containers in basement, in accordance with all state and local hazardous waste laws/regulations.

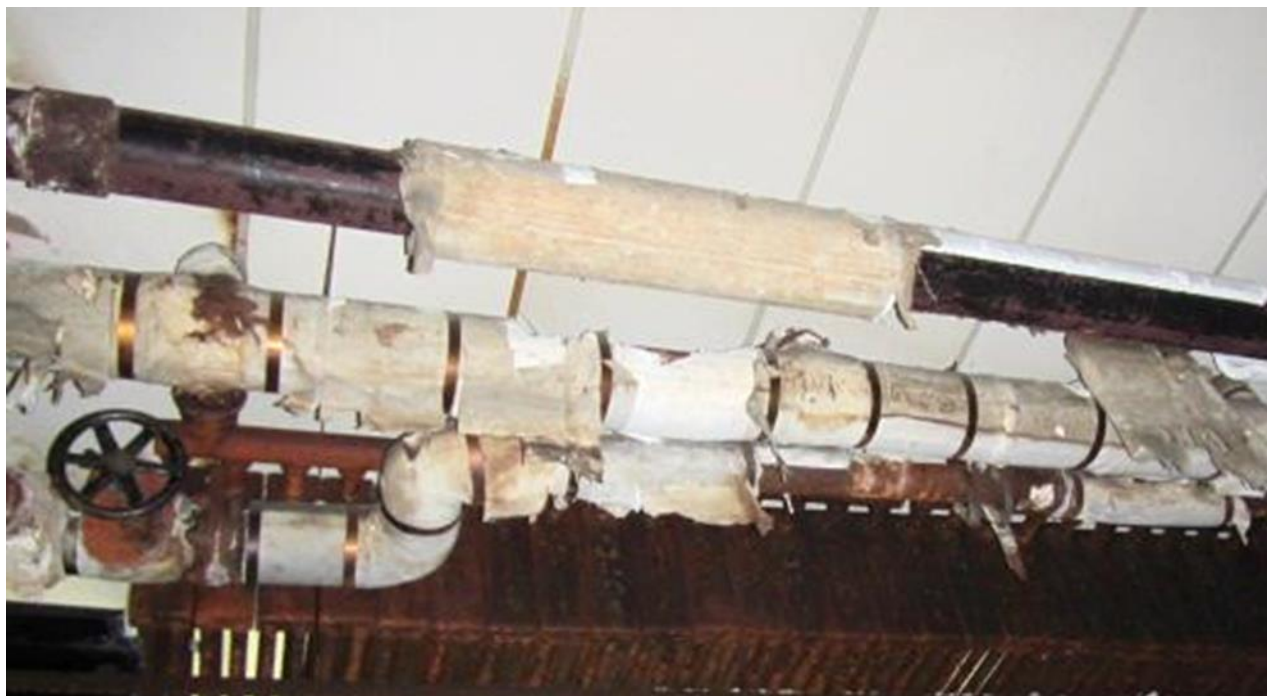
Picture 14

BEH/IAQ staff noted numerous areas of what appeared to be severely damaged and friable insulation material throughout the building. Facilities staff reported that samples were sent to a third party consultant to be tested for asbestos content. Lab results were not available to BEH/IAQ staff at the time of the assessment. The damaged/friable materials observed were ductwork insulation, pipe wrap insulation, floor tiles, and interlocking ceiling tiles (Pictures 14 through 18).

Damaged pipe insulation

1. Follow DLS and FHD guidance regarding the safety of building occupants in regards to the likely presence of asbestos-containing materials in the Danforth building. Lab results and the feasibility of creating temporary barriers and/or the use of depressurization techniques may dictate whether the building can continue to be occupied should the presence of friable asbestos-containing materials be confirmed and found to exceed acceptable levels in occupied areas.

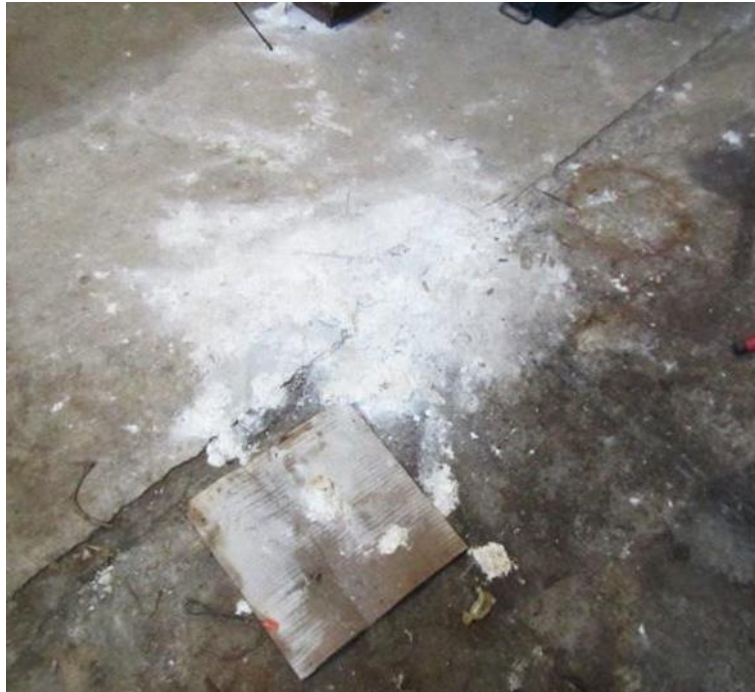
Picture 15

Damaged insulation material on floor of basement

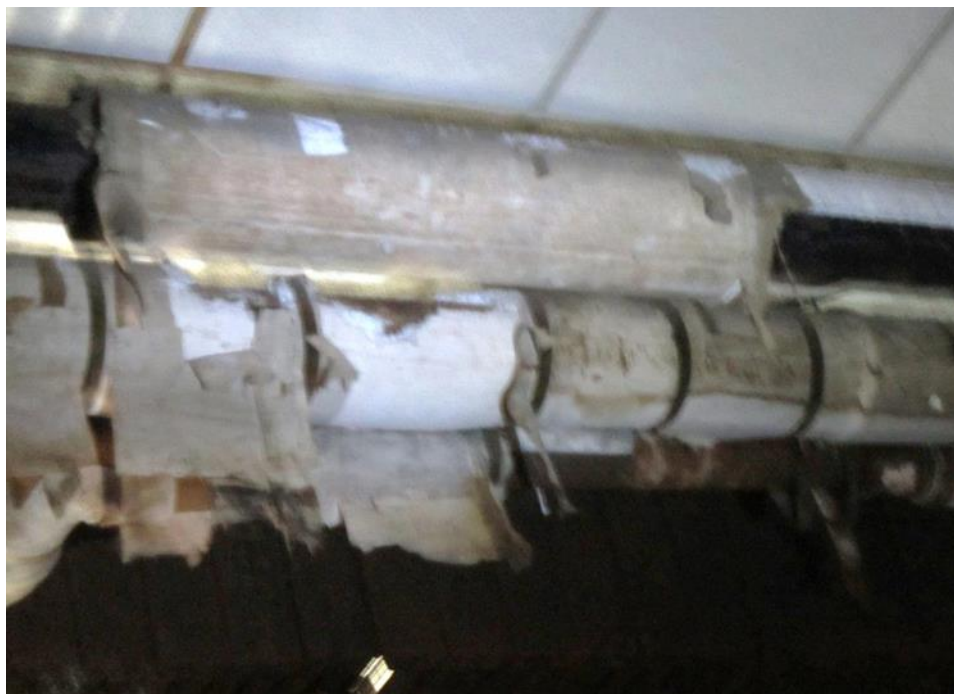
Picture 16

Damaged pipe insulation

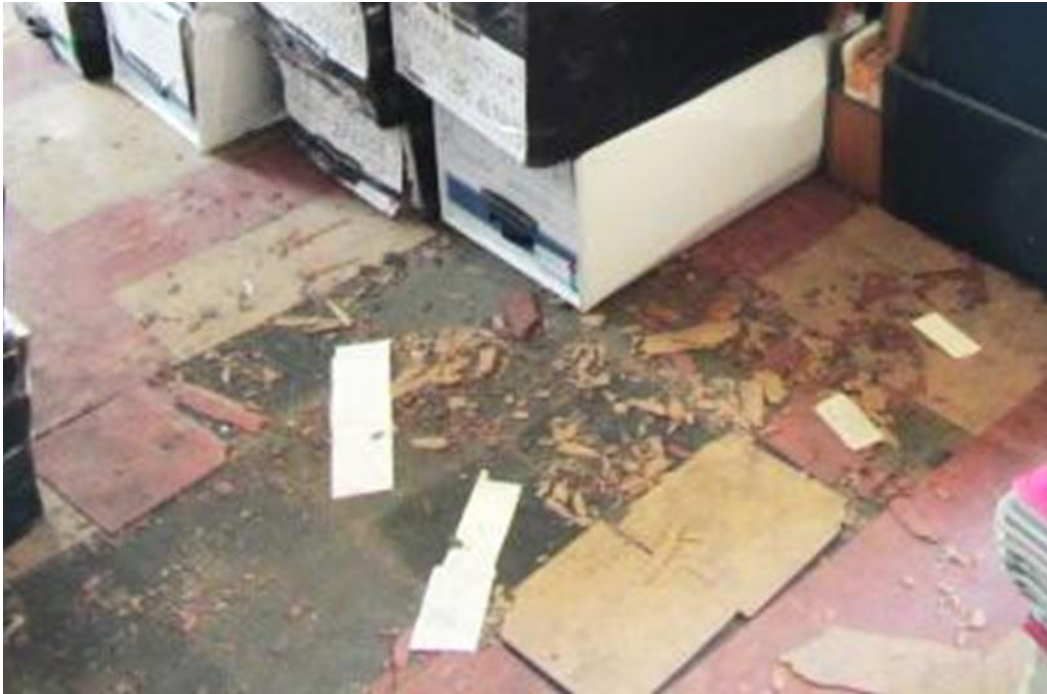
Picture 17

Pulverized floor tiles

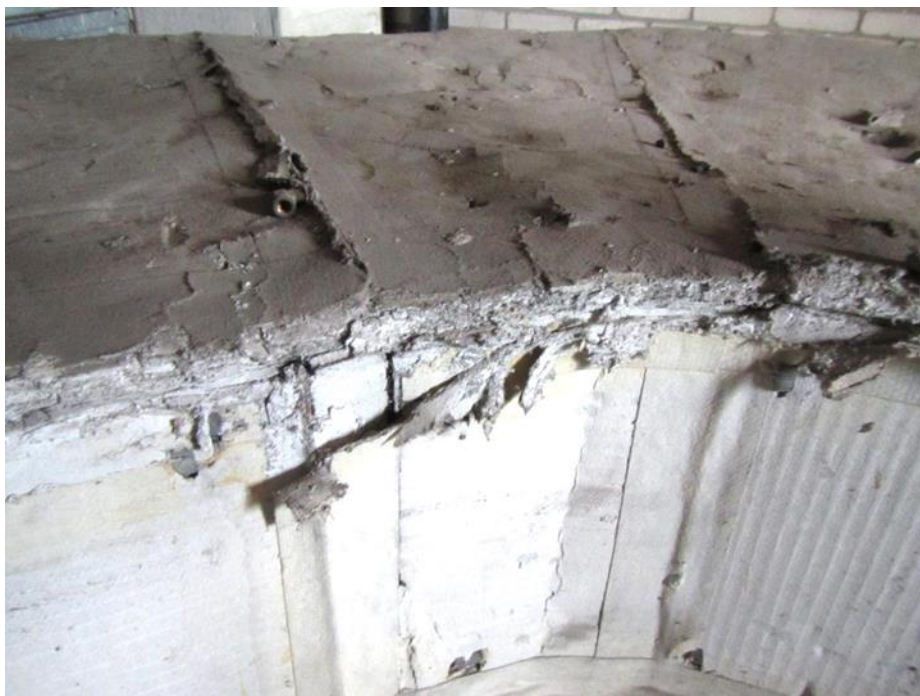
Picture 18

The abandoned ventilation ductwork may also serve as a pathway for pollutants. BEH/IAQ staff observed the rooftop mechanical room to have severely damaged duct insulation (Picture 18). The ductwork was noted to have breaches (Picture 19), which may allow the migration of these pollutants to occupied areas through the stack effect and other pressure/temperature differentials. Abandoned vents were noted in some occupied areas and appeared to be connected to this system. Some of these vents were found to be sealed (Picture 20) and some were open (Picture 21).

Damaged insulation material around ductwork in rooftop mechanical room

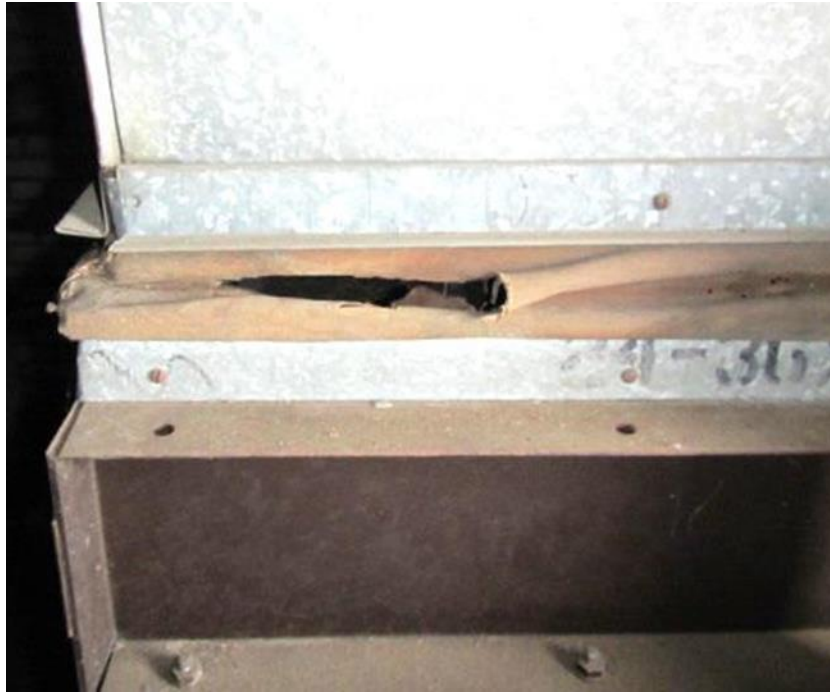
Picture 19

Rip/breach in ductwork in rooftop mechanical room

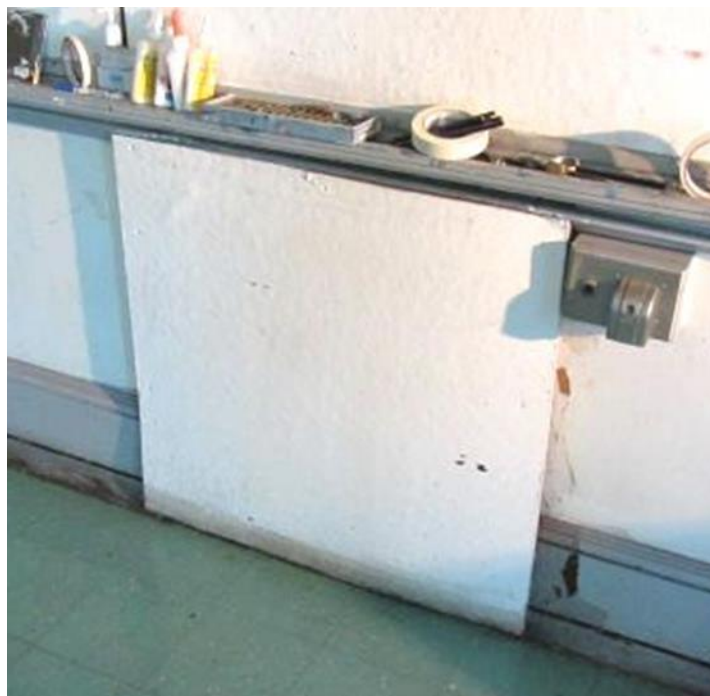
Picture 20

Sealed vent

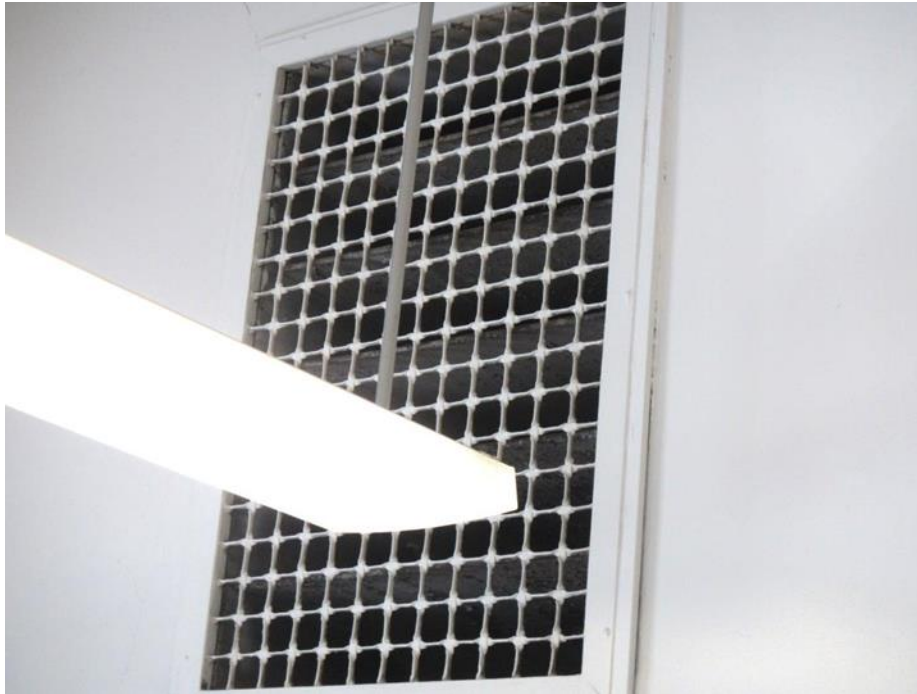
Picture 21

Open vent

6. Seal all vents for the abandoned HVAC system in occupied areas.
7. Remove all water-damaged porous items and building materials with recommendations found in “Mold Remediation in Schools and Commercial Buildings” published by the US Environmental Protection Agency (US EPA, 2008). Available at: <http://www.epa.gov/mold/mold-remediation-schools-and-commercial-buildings-guide>.

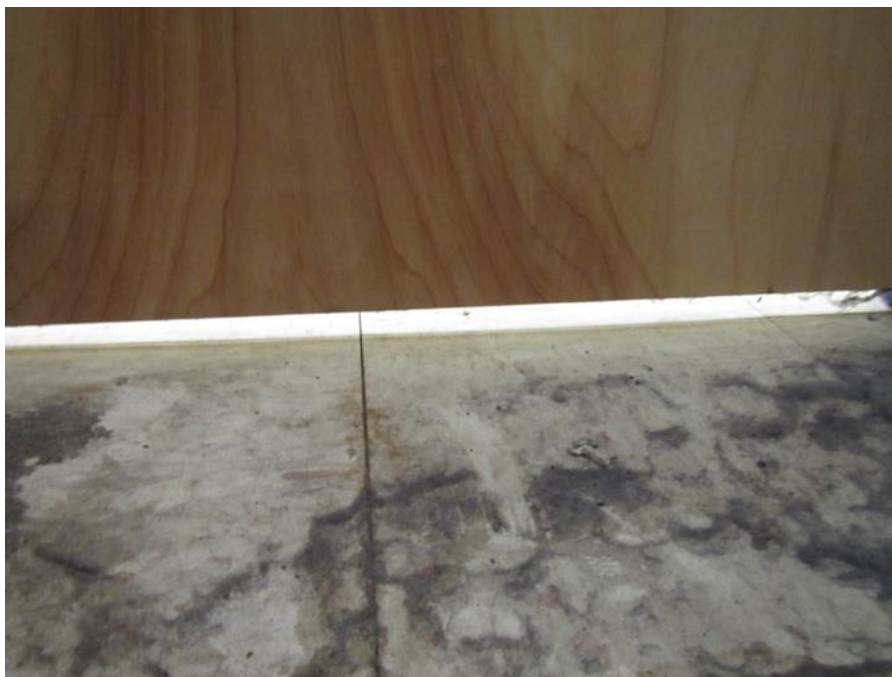
Picture 22

Doors separating occupied areas from unoccupied areas had large gaps beneath them (Picture 22). These gaps may serve as additional pathways for pollutants to travel into occupied areas. In general, doors to unconditioned areas or areas of point source pollutants should be sealed with tight-fitting door sweeps to mitigate this effect.

Spaces under door separating occupied areas and areas where damaged insulation material was seen

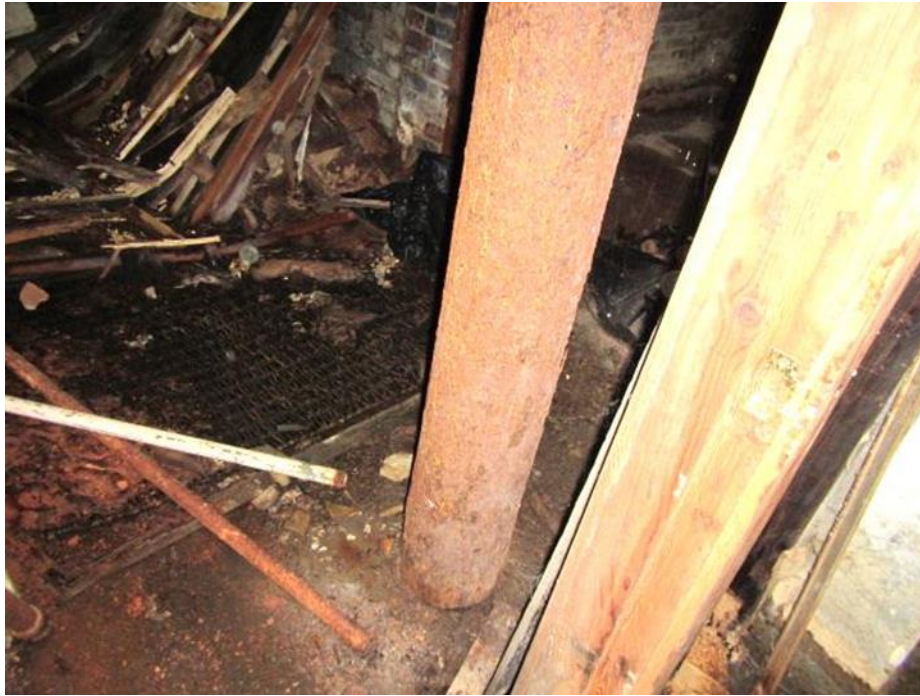
Picture 23

Potential structural issues were noted in the basement in the form of corroded metal support beams (Picture 23) and damaged/spalling concrete beams (Pictures 24 and 25), which in some cases are reported to support the weight of the parking lot. These issues should be examined by a building engineer for structural integrity/safety reasons.

Corroded metal support beam

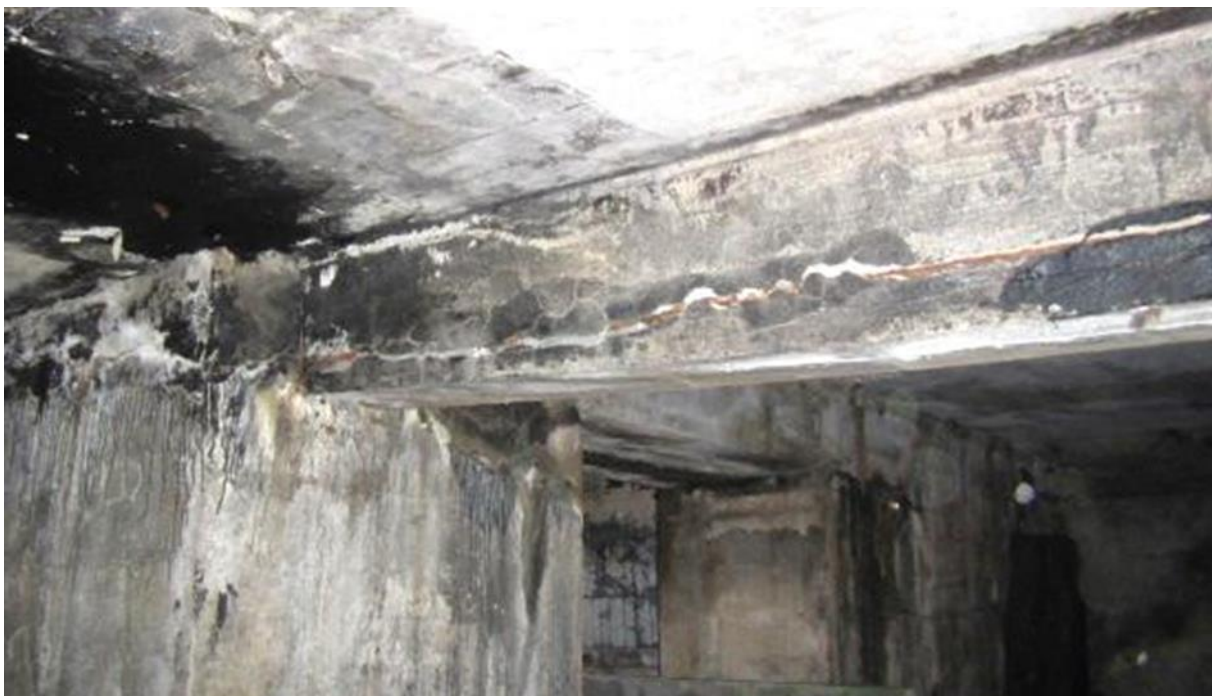
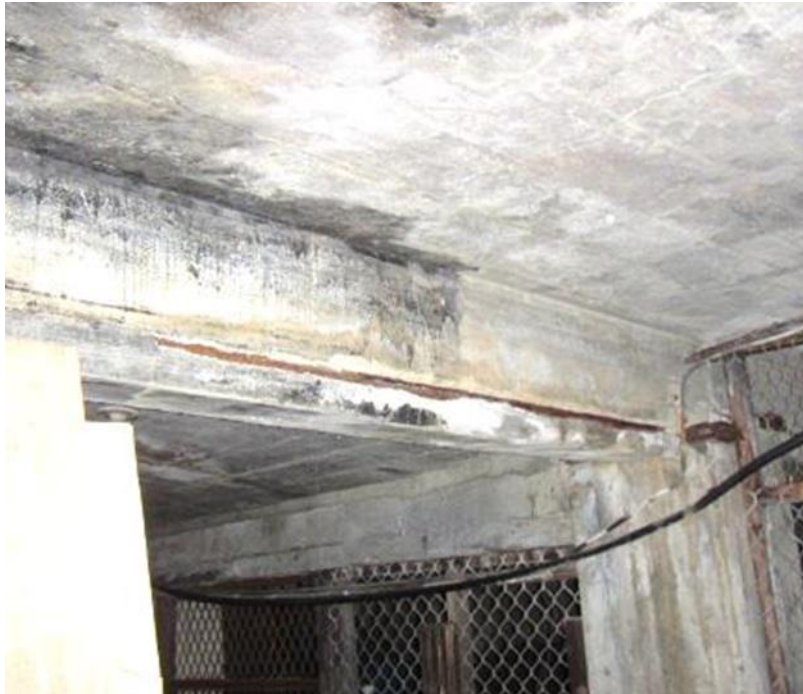
Damaged concrete support beams, note metal showing through

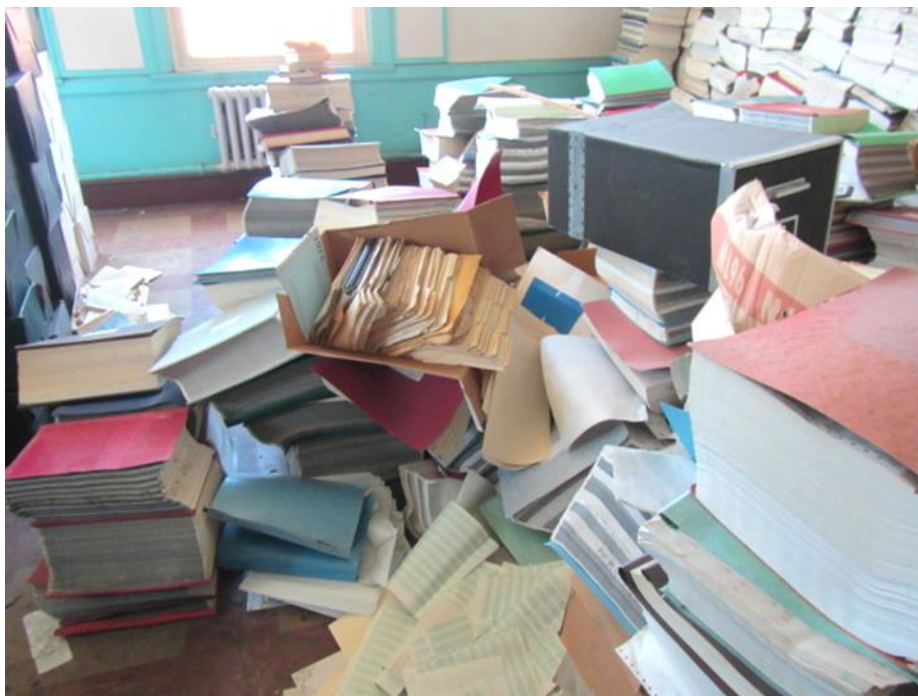
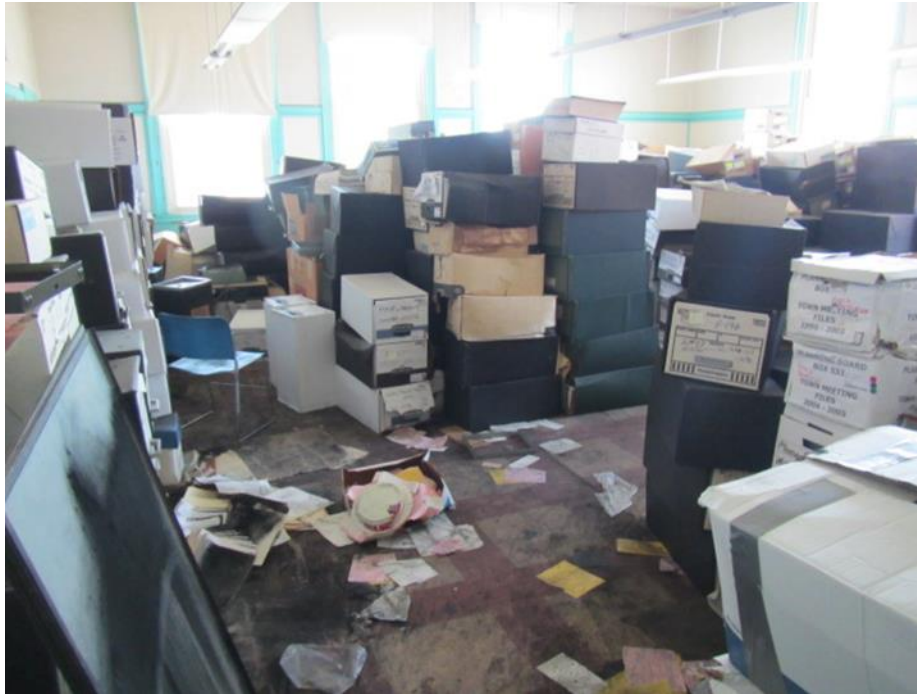
Accumulated items were found stored on floors and other flat surfaces. Boxes and other items were often found stored directly in contact with floors (Pictures 26 and 27), which may be subject to condensation and lead to additional water damage. In addition, large quantities of paper can provide harborage for pests and may represent a fire hazard. A systematic review of stored paperwork and other items should be conducted with a goal of reducing the overall amount of items and reorganizing the remaining items to be stored in a manner (contained and away from floors) that will prevent further damage, deterioration and odors.

Cardboard boxes/paper materials directly on floor in unconditioned space

18. Reduce the amount of stored materials to allow for more thorough cleaning. Clean items regularly with a wet cloth or sponge to prevent excessive dust build-up.

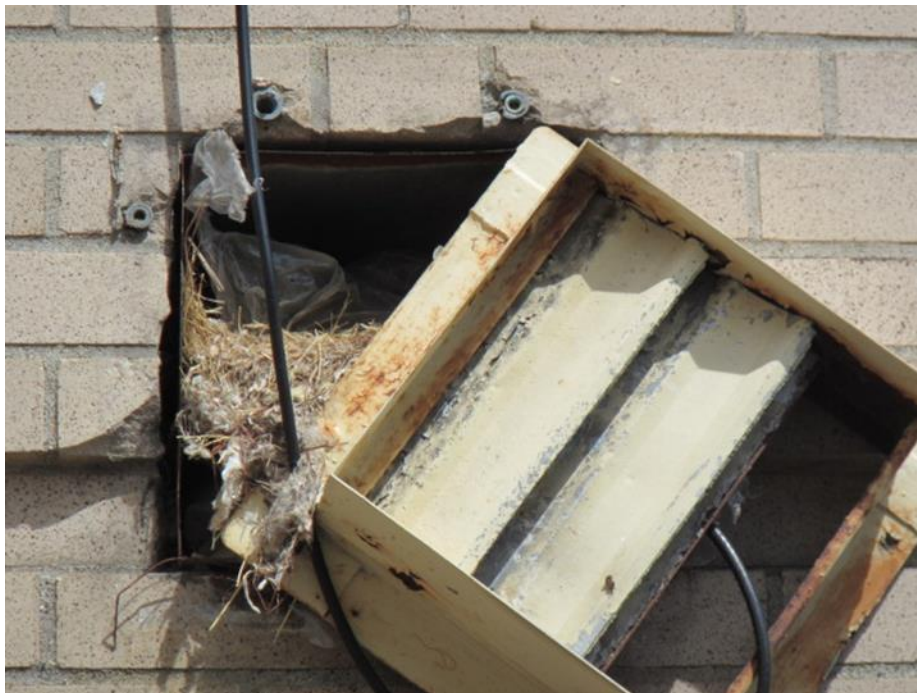
Picture 28

Finally, birds/nesting materials were observed inside vents of unknown origin along the exterior of the building (Picture 28). Birds can be a source of disease, and bird wastes and feathers can contain mold, bacteria and pests (e.g., bird mites), which can be irritating to the skin and respiratory system. Birds/nests should be removed and the vents sealed on both the interior and exterior if not needed/abandoned.

Birds/nesting materials in exterior vent

13. Ensure birds/nesting materials are removed from vents/louvers on exterior of building. Clean and disinfect with an appropriate antimicrobial. If vents not needed, ensure they are properly sealed to prevent further roosting.
